MDSF Servo Electric Drive User's Manual

E.H. Wachs Part No. 69-SERVO-MAN-01
Rev. A, July 2022

MDSF Servo Electric Drive

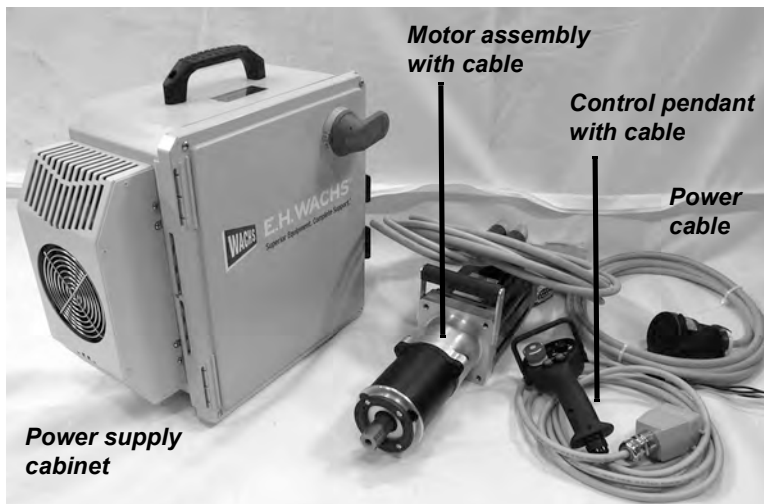
Figure 1-1. The photo shows the components of the servo electric drive.

The system includes the following components:

- power supply cabinet with on/off switch and electronic error code display panel
- electric drive motor assembly with adapter for mounting to MDSF pinion housing
- control pendant with start/stop, speed control, and emergency stop
- power cable
- storage/shipping case
- optional drive adapter (81-180-00) for EP 424.

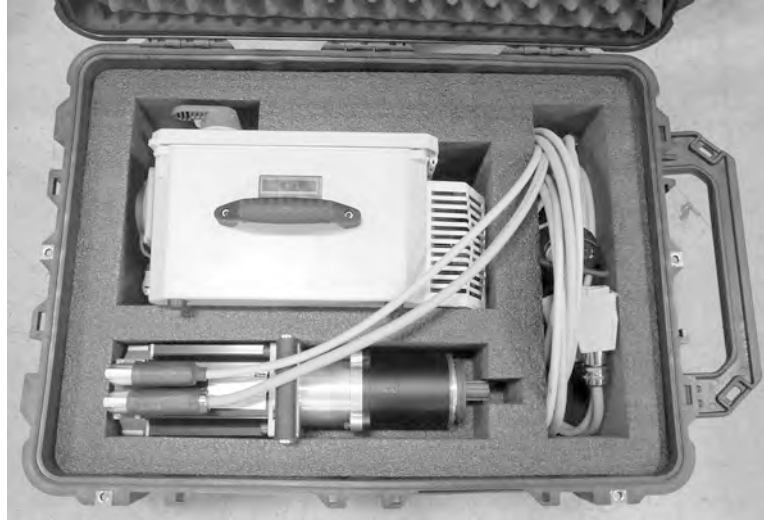
Figure 1-2. The drive system is provided in a custom storage/shipping case. Keep all components stored in the case when not in use.

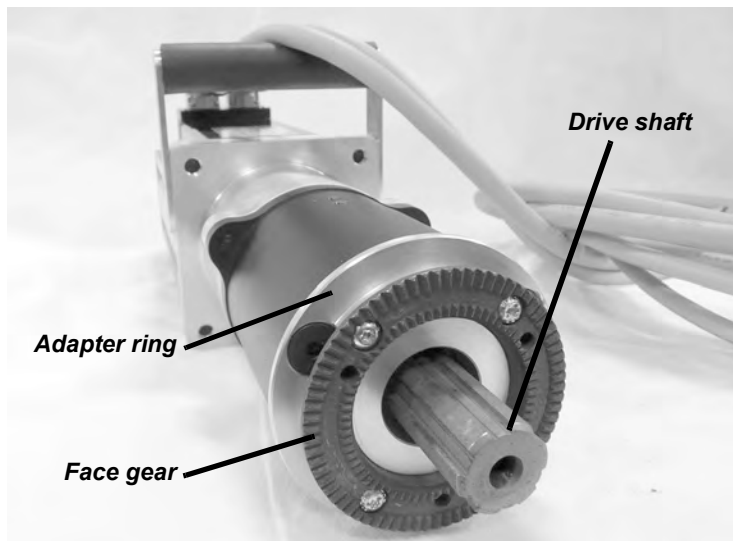
Figure 1-3. The photo shows the motor mounting interface to the MDSF.

1. Mount and position the MDSF on the pipe according to the instructions in the MDSF user's manual.
2. Mount the motor to the MDSF pinion assembly. Use a lifting device if necessary; the drive motor assembly has a lift handle.
 - Insert the motor drive shaft all the way into the pinion spline, engaging the face gear.
 - Snap the motor mounting clamp handle over the motor adapter ring.

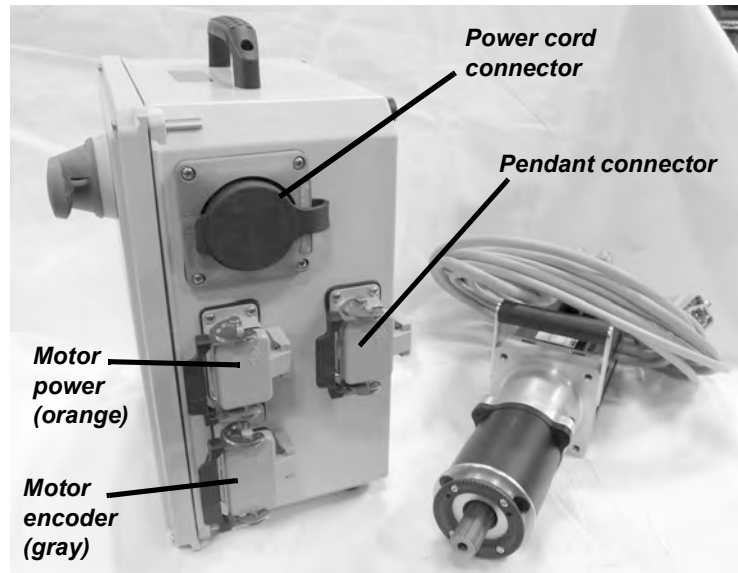
Figure 1-4. Attach the cables to the control cabinet as shown.

1. A power cable for the appropriate electrical service is provided with the control cabinet. Connect it to the back of the control cabinet.
 - **NOTE: Do not plug the power cable into the electrical source until you have the machine and drive mounted and ready to operate.**
2. Connect the power (orange) and feedback (gray) cables from the drive motor assembly to the back of the control cabinet.
3. Attach the pendant cable to the connector on the control cabinet.

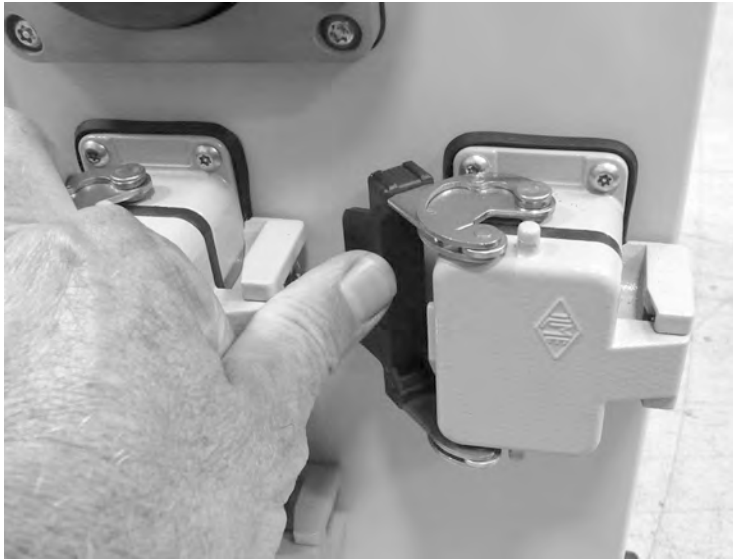
Figure 1-5. Press the tab as shown to unlock the connector cover.

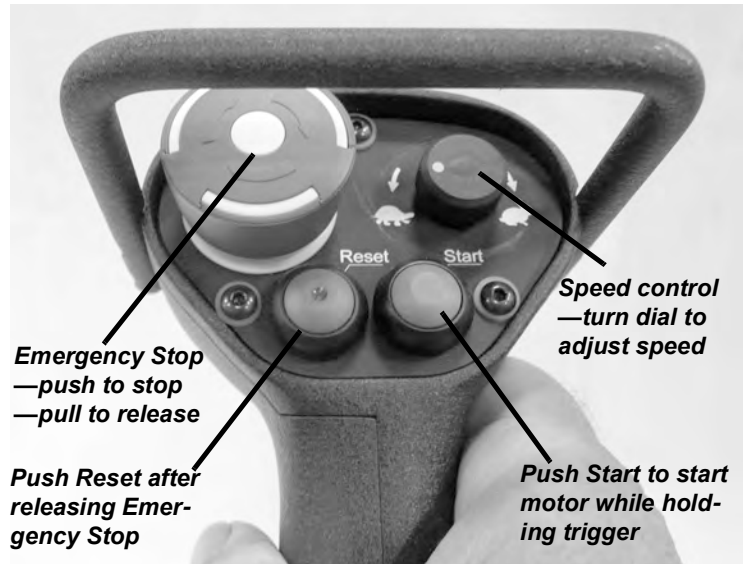
Figure 1-6. Use the control pendant to operate the drive.

When not operating the drive, push in the Emergency Stop button to prevent accidentally engaging the motor.

To re-enable operation, pull out the Emergency Stop button, then press the Reset button.

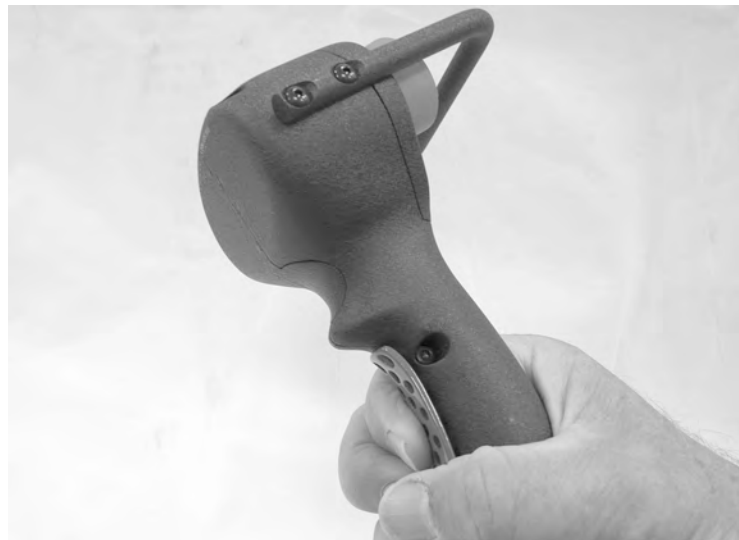
Figure 1-7. Squeeze the hold-to-run trigger to operate the motor. Releasing the trigger will stop the motor; to re-start, hold the trigger and press the **Start** button.

After releasing the trigger, you will have to squeeze the trigger and press **Start** again to re-start the motor.

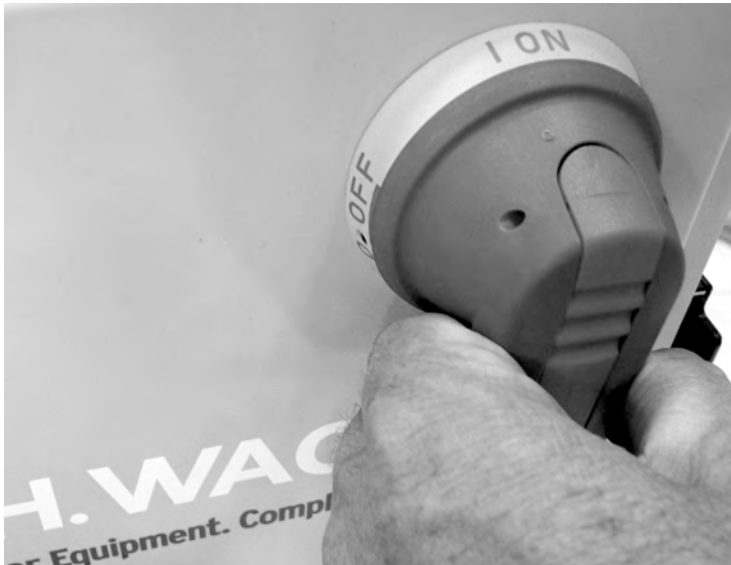
Figure 1-8. Turn the power switch to the ON position.

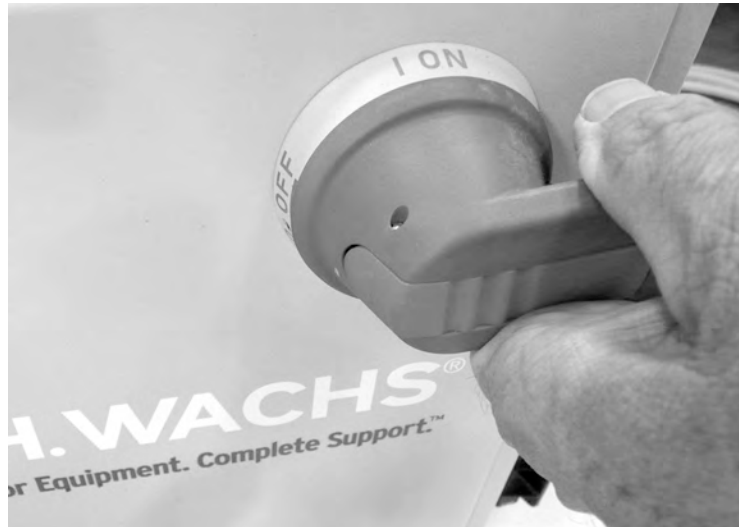
Figure 1-9. Turn the main power off when finished or when changing connections.

- 11.** Turn the speed dial clockwise to increase the speed to the desired speed.
- 12.** As the machine operates, continue holding the trigger and adjust the speed as necessary using the speed dial. Release the trigger to stop the machine.
- 13.** If necessary, press the Emergency Stop button on the pendant to immediately stop the machine and disable power.
- 14.** Always press in the Emergency Stop button when making adjustments to the cutting machine.
- 15.** Turn the main power switch on the cabinet OFF when the operation is complete, or when connecting or disconnecting any components.

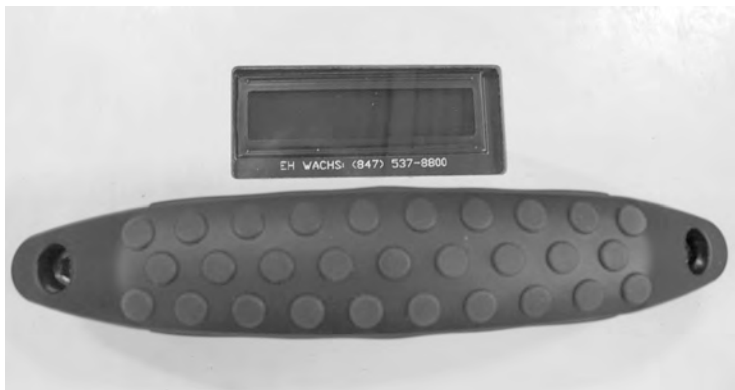
Figure 1-10. The LCD screen on top of the control cabinet displays error codes during operation.

The LED display on top of the control cabinet displays error codes when there is an error condition. Appendix A lists and describes the error codes.
